Title: **Why Indeed Did the WTC Buildings Completely Collapse?**

Description: *Thirteen Reasons to Challenge Government-sponsored Reports and to Investigate the Controlled-demolition Hypothesis*

Author: Dr. Steven E. Jones, Journal of 9/11 Studies 5 September 2006/Volume 3

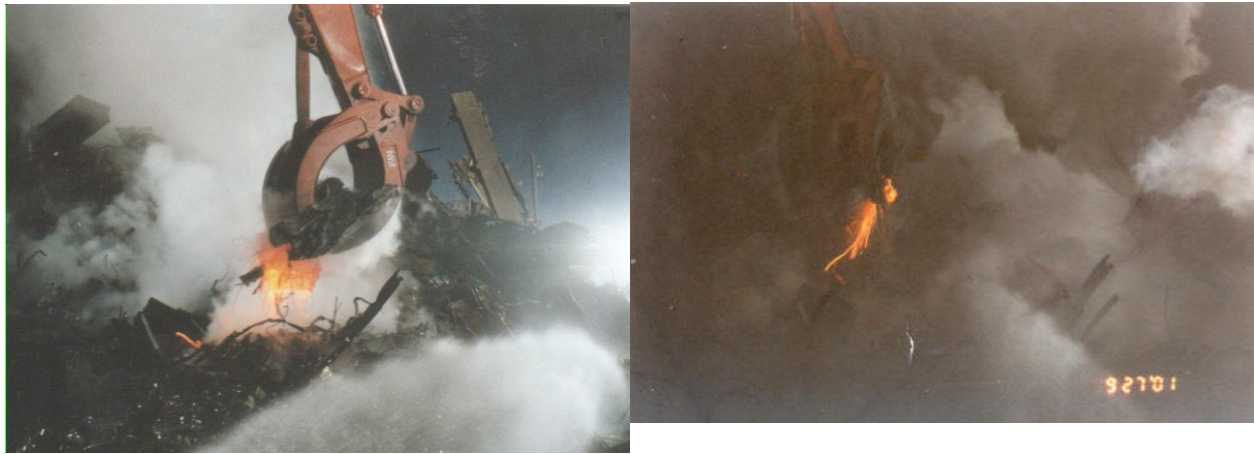
We start with the fact that large quantities of molten metal were observed in basement areas under rubble piles of all three buildings: the Twin Towers and WTC7. A video clip provides eye-witness evidence regarding this metal at ground zero: **http://plaguepuppy.net/public_html/video%20archive/red_hot_ground_zero_low_quality.wmv**. The photographs below by Frank Silecchia show chunks of the hot metal being removed from the North Tower rubble on September 27, 2001 (according to photographer's aid). Notice the color of the lower portion of the extracted metal -- this tells

us much about the temperature of the metal and provides important clues regarding its composition, as we shall see.

Even without a direct elemental analysis, we can rule out some metals based on available data. The photograph in the introduction shows a chunk of hot metal being extracted at ground zero. The hottest portion of the chunk is the lower portion, which was deepest down in the slag, and the metal is seen to be yellow-hot, certainly above cherry-red hot. The following table (see <http://www.processassociates.com/process/heat/metcolor.htm>) provides data regarding the melting temperatures of lead, aluminum, structural steel and iron, along with approximate metal temperatures by color. Note that the approximate temperature of a hot metal is given by its color, quite independent of the composition of the metal. (A notable exception is falling liquid aluminum, which due to low emissivity and high reflectivity appears silvery-gray in daylight conditions, after falling through air 1-2 meters, regardless of the temperature at which the poured-out aluminum left the vessel. Aluminum does incandesce (glow) like other metals, but faintly, so that with the conditions described in the previous sentence (which prevailed at the WTC on 9/11), falling liquid aluminum will appear silvery-gray. Rapid oxidation of the hot flowing aluminum will contribute to the observed appearance. [Experiments: Jones, 2006])

We see from the photograph above that solid metal from the WTC rubble existed at salmon-to-yellow-hot temperature (approx. 1550 - 1900 °F, 845 - 1040 °C.) The temperature is well above the melting temperatures of lead, zinc and aluminum, and these metals can evidently be ruled out since they would be runny liquids at much lower (cherry-red or below) temperatures. However, the observed hot specimen could be structural steel (from the building) or iron (from a thermite reaction) or a combination of the two. Additional photographs of the hot metal could provide further information and advance the research.

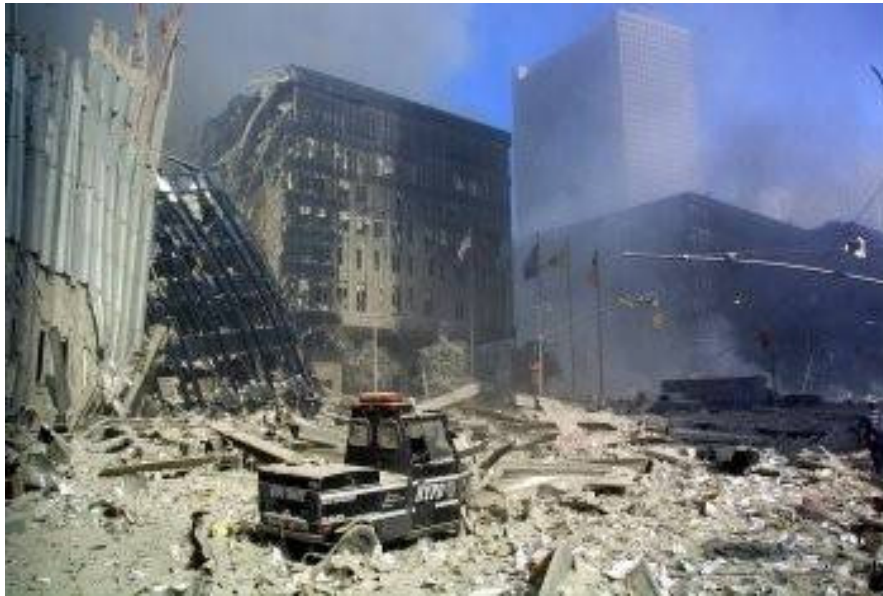
WTC 7 on 9-11-01. WTC 7 is the tall sky-scraper in the background, right. Seen from WTC plaza / Church Street area.

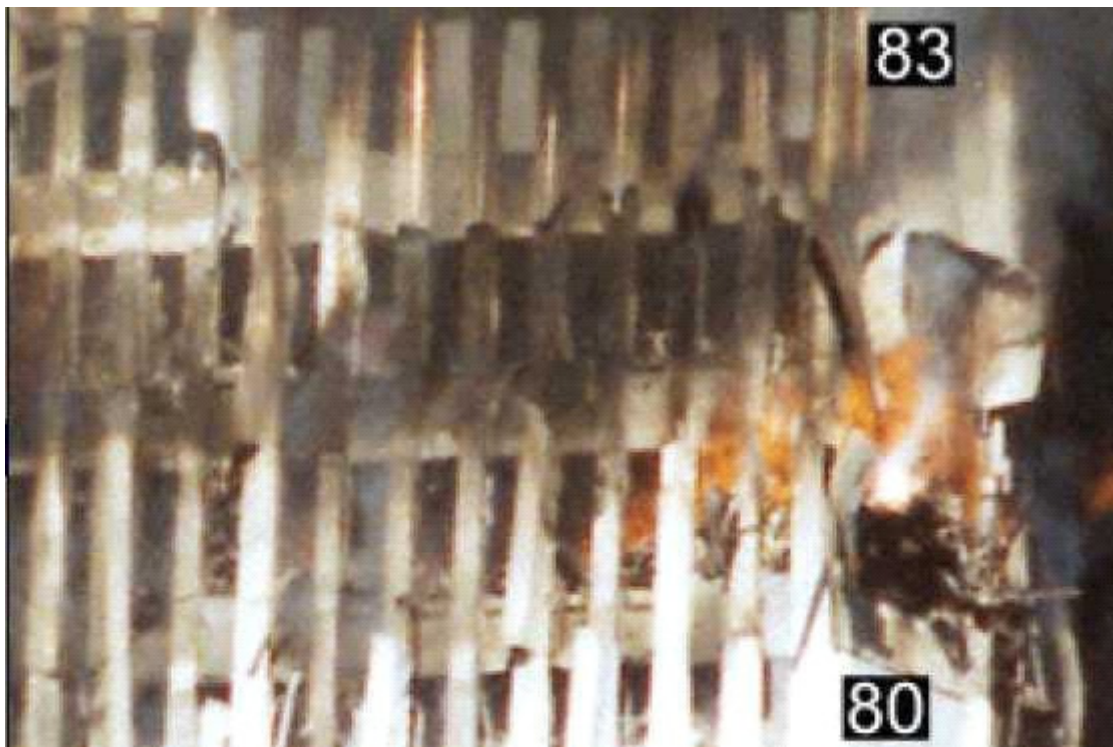
An intriguing photograph found as Figure 9-44 in the NIST report provides evidence for a highly exothermic reaction at the corner of the South Tower just minutes before its collapse. Furthermore, failure occurs at this very corner of the Tower as seen in this video footage:

Regarding this photo, NIST states:

“An **unusual flame** is visible within this fire. In the upper photograph {Fig 9-44} a **very bright flame, as opposed to the typical yellow or orange surrounding flames**, which is **generating a plume of white smoke**, stands out.” Source: NCSTAR 1-5A Chapter 9 Appendix C NIST Fig. 9-44. p. 344

Thus it is established that the "glowing liquid" flow is associated spatially and temporally with the "bright spot" observed on the corner of the 80th floor of WTC 2. The photograph below shows, for comparison, a thermite reaction with a white aluminum-oxide dust plume extending from very bright reaction region. (Experiment by the author and colleagues in which thermite-plus-sulfur cut through a steel cup in a fraction of a second. Any thermite reaction is a dangerous reaction and should only be performed by a trained professional capable of assessing the hazards and risks.) The similarities between the known thermite reaction and the hitherto unknown reaction at the WTC Tower are plain to see. These discoveries strongly motivate an immediate in-depth investigation of the use of thermite-type reactions in the destruction of the World Trade Center on 9/11/2001.

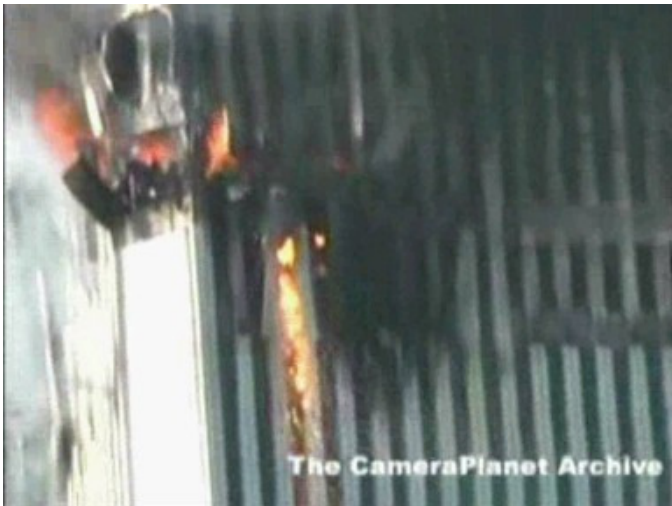
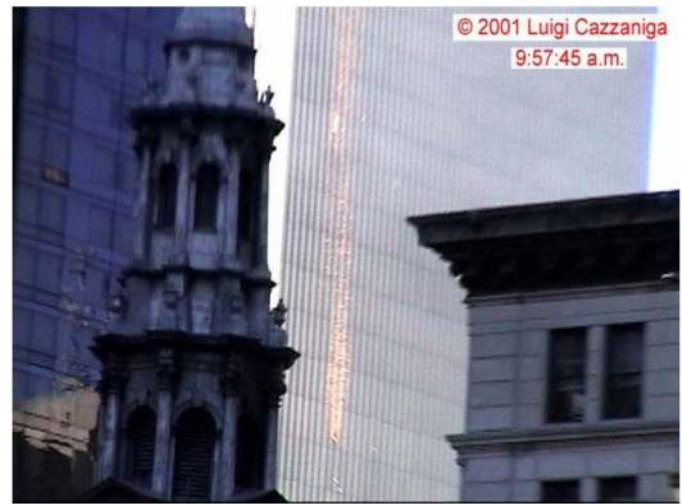
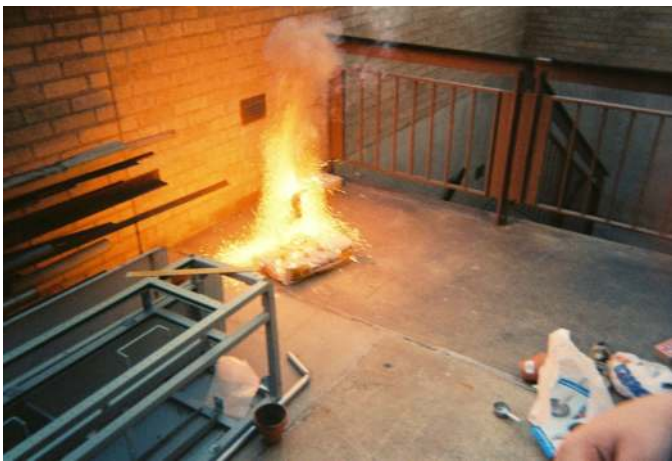
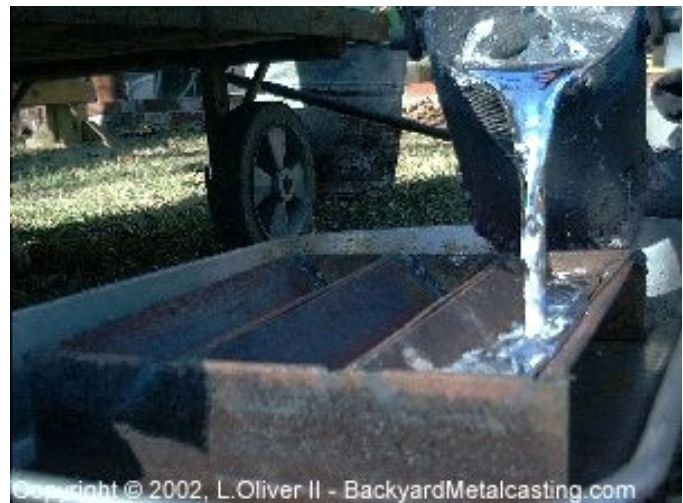
Is the falling molten metal from WTC Tower 2 (Top photos) more likely molten iron from a thermite reaction (lower left) OR pouring molten aluminum (lower right)?

Who can deny that liquid, molten metal existed at the WTC disaster? The yellow color implies a molten-metal temperature of approximately 1000 °C, evidently above that which the dark-smoke hydrocarbon fires in the Towers could produce. If aluminum (e.g., from the plane) had melted, it would melt and flow away from the heat source at its melting point of about 650 °C and thus would not reach the yellow color observed for this molten metal. Thus, molten aluminum is already ruled out with high probability. But molten iron with the characteristics seen in this video is in fact consistent with a thermite-reaction attacking the steel columns in the Tower, thus weakening the building just prior to its collapse, since thermite produces molten iron at yellow-to-white hot temperatures. (As some of the molten metal hits the side of the building in the video clip above, the white-hot interior is evidently exposed as the metal "splashes".) Also, the fact that the liquid metal retains an orange hue as it nears the ground (right photograph) further rules out aluminum, and suggests a mid-flight thermite reaction (typical of thermite). Here are two independent videos of the yellow-white liquid metal pouring out of the South Tower: <http://video.google.com/videoplay?docid=->

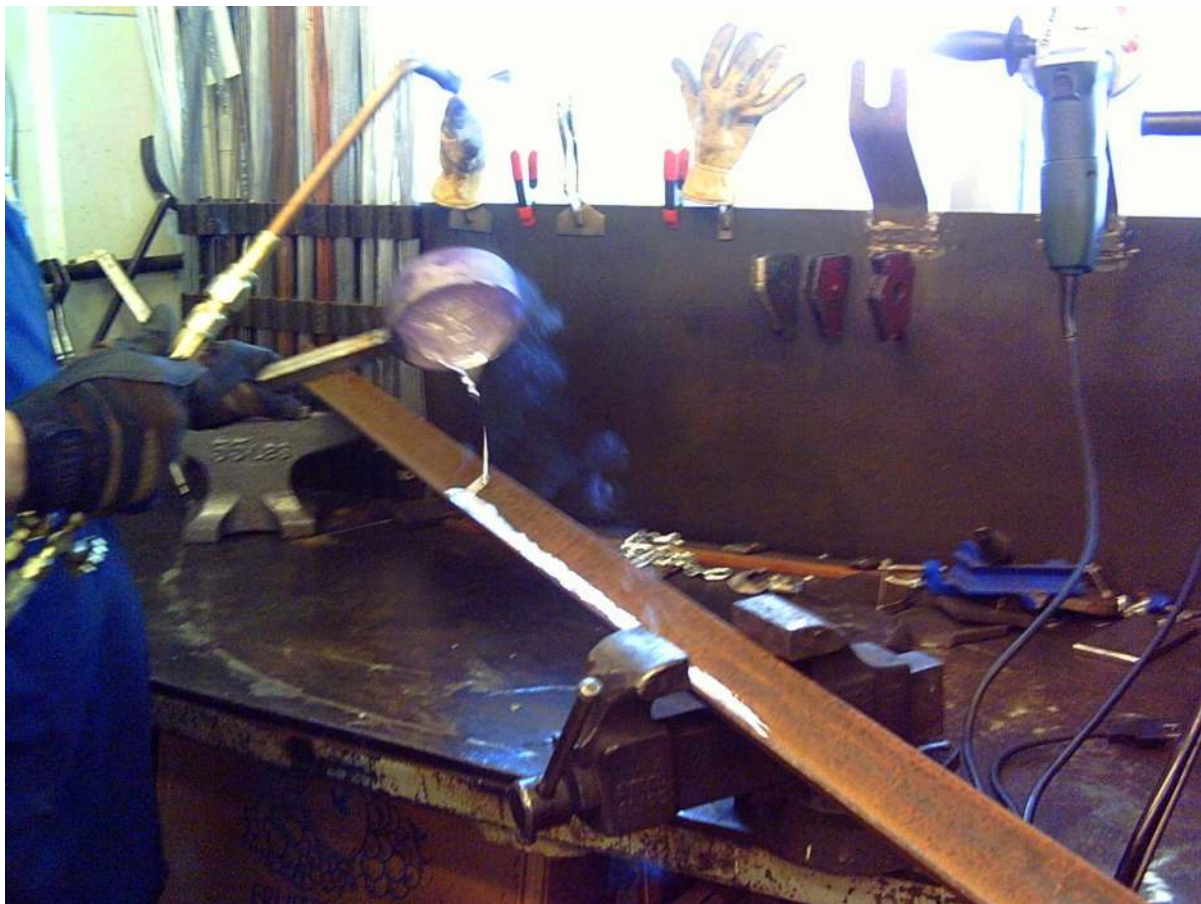
We also noted that while a steel pan holding the aluminum glowed red and then yellow hot, when poured out the falling aluminum displayed a silvery-gray color, adding significantly to the evidence that the yellow-white molten metal flowing out from the South Tower shortly before its collapse was NOT molten aluminum. (Recall also that the yellow color of the molten metal (video clip above) implies a temperature of approximately 1100°C -- too high for the dark-smoke hydrocarbon fires burning in the building.) This is a point worth emphasizing: aluminum has low emissivity and high reflectivity, so that in daylight conditions after falling through air 1-2 meters, molten aluminum will appear silvery-gray, while molten iron (with its characteristic high emissivity) will appear yellow-white (at ~1100°C) as observed in the molten metal dripping from the South Tower just before its collapse (see: <http://www.supportthetruth.com/jones.php>). We also recall that this molten metal, after falling approximately 150 meters (or yards) still retained a reddish orange color (photograph above). This is not the behavior of falling, molten aluminum.

Molten aluminum poured onto rusted steel: silvery flow, and **no** violent reactions observed at all (contrary to predictions by some of a vigorous aluminum-rust “thermitic reaction”). Same result -- when the rusty steel piece was pre-heated with the torch.

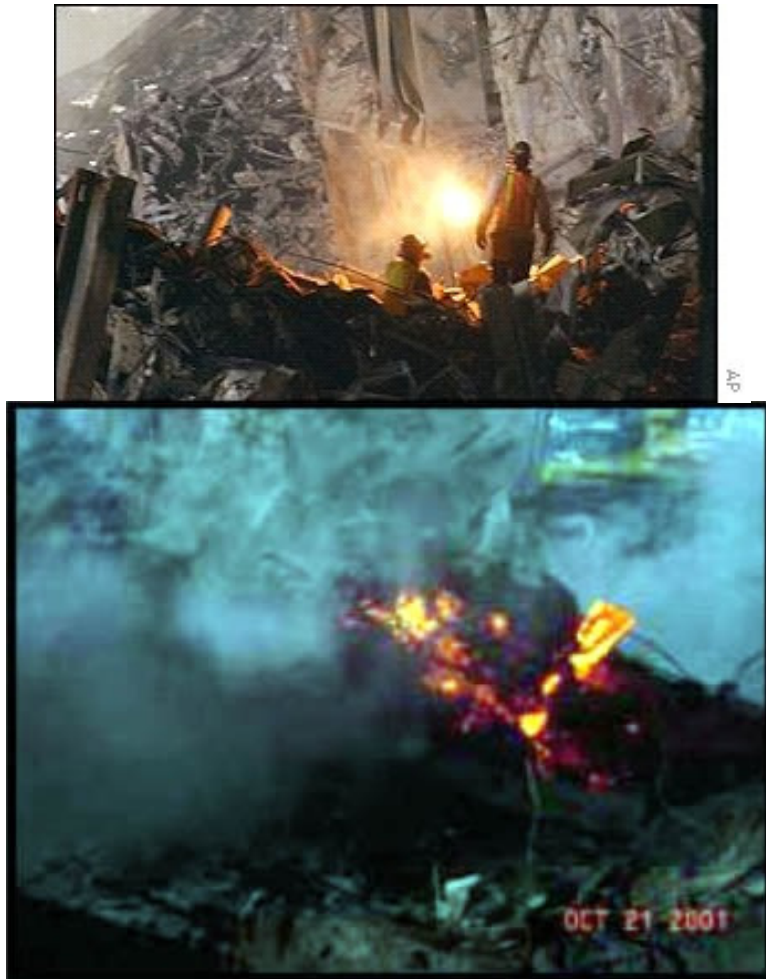
The top photo (<http://news.bbc.co.uk/2/hi/science/nature/1858491.stm>) may show the glow of hot metal in the rubble; the second photo clearly does so. It is labeled "Red Hot Debris" and is published in **LiRo News, Nov. 2001**, <http://www.liro.com/lironews.pdf>. Moreover, there is recorded eyewitness testimony of the molten metal pools under both Towers and WTC 7; see: <http://georgewashington.blogspot.com/2005/12/why-was-there-molten-metal-under.html>. Video clips provide eye-witness evidence regarding this metal at ground zero: http://plaguepuppy.net/public_html/video%20archive/red_hot_ground_zero_low_quality.wmv, <http://video.google.com/videoplay?docid=-3060923273573302287>.

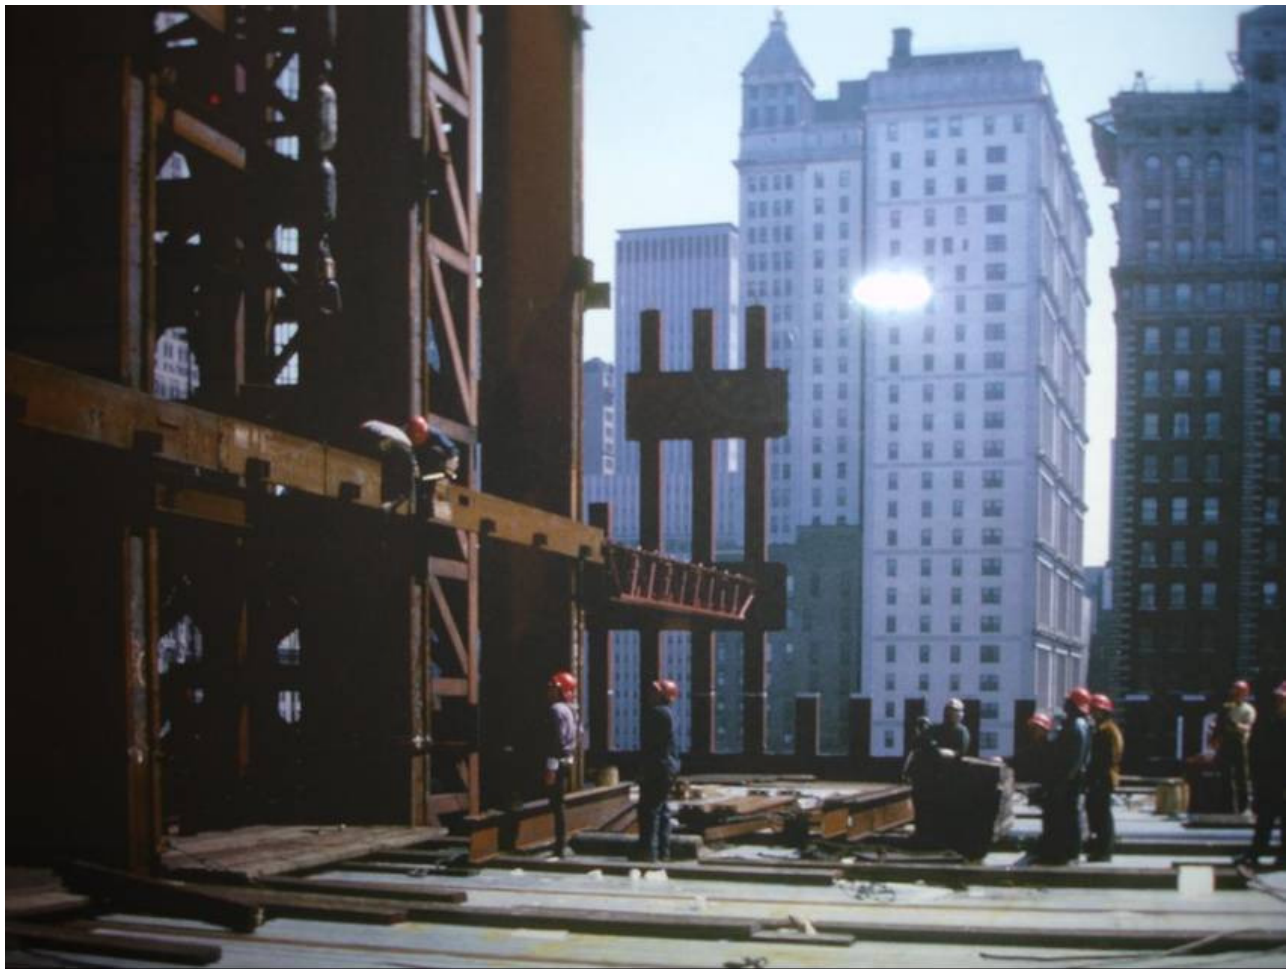
Steel-frame: Huge core (left) is an enormous heat sink. Notice workers standing on floor pan which is firmly attached to the interconnected core columns. Clearly, **the Towers were not “hollow tubes.”**
